# The Application of High-Pressure Connectors in UHPLC

White Paper

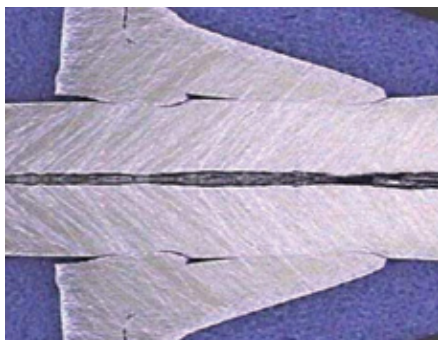
**Figure 2.** Tubing ID compression

However, some of the most popular all-metal fittings require a high-torque load to ensure they swage properly on the tubing wall. When the need for a high-tightening torque is coupled with the axiom that says “you can never tighten too much,” the stage is set to significantly compress the ID of the flow path tubing.

### **Compression shown in Figure 2 results in several problems:**

- › Higher system back pressures.
- › A “throttling effect” on the fluid, resulting in increased turbulence and excessive mixing between the sample and mobile phase.
- › Increased probability of tubing clogs due to suspended particulate matter.

Similar to the problem with tubing slippage, tubing ID compression is also difficult to detect. There are no leaks present and no loss of pressure, making this problem tough to troubleshoot and often resulting in unnecessary system down time and repair expenditures.

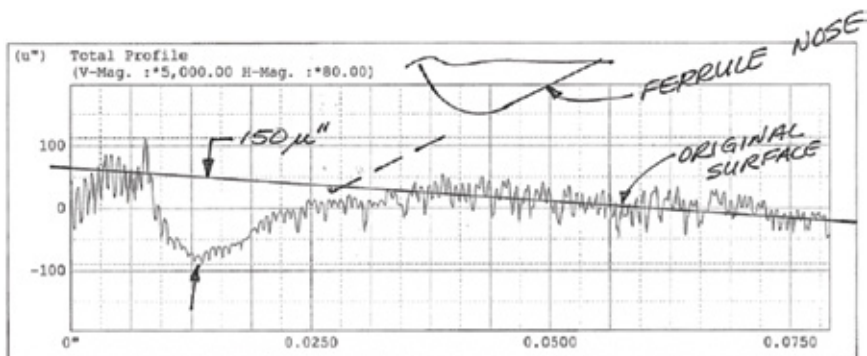
Even if galling doesn't occur, it's very typical for all-metal fittings to slightly damage the conical surface inside the receiving port. As seen in Fig. 4, it's possible for a ferrule to indent the conical surface by as much as 150  $\mu$ -inches.

Figure 4. Profilometer scan showing that galling has occurred

The strength of a connection relies partially on the quality of the receiving port. While competitive products can leave a damaging impression on the receiving port, as great as 150 μ-inches (shown in Figure 4 on page 3), the VHP-200 fittings create less than half of the impression on the receiving port (see Figure 8).
